**Archaeological
Building Survey:**

Worsley New Hall
Cold War Bunker,
Worsley. Final
Version.

Client: Peel
Investments (North)
Ltd.

Report No: 02/2012

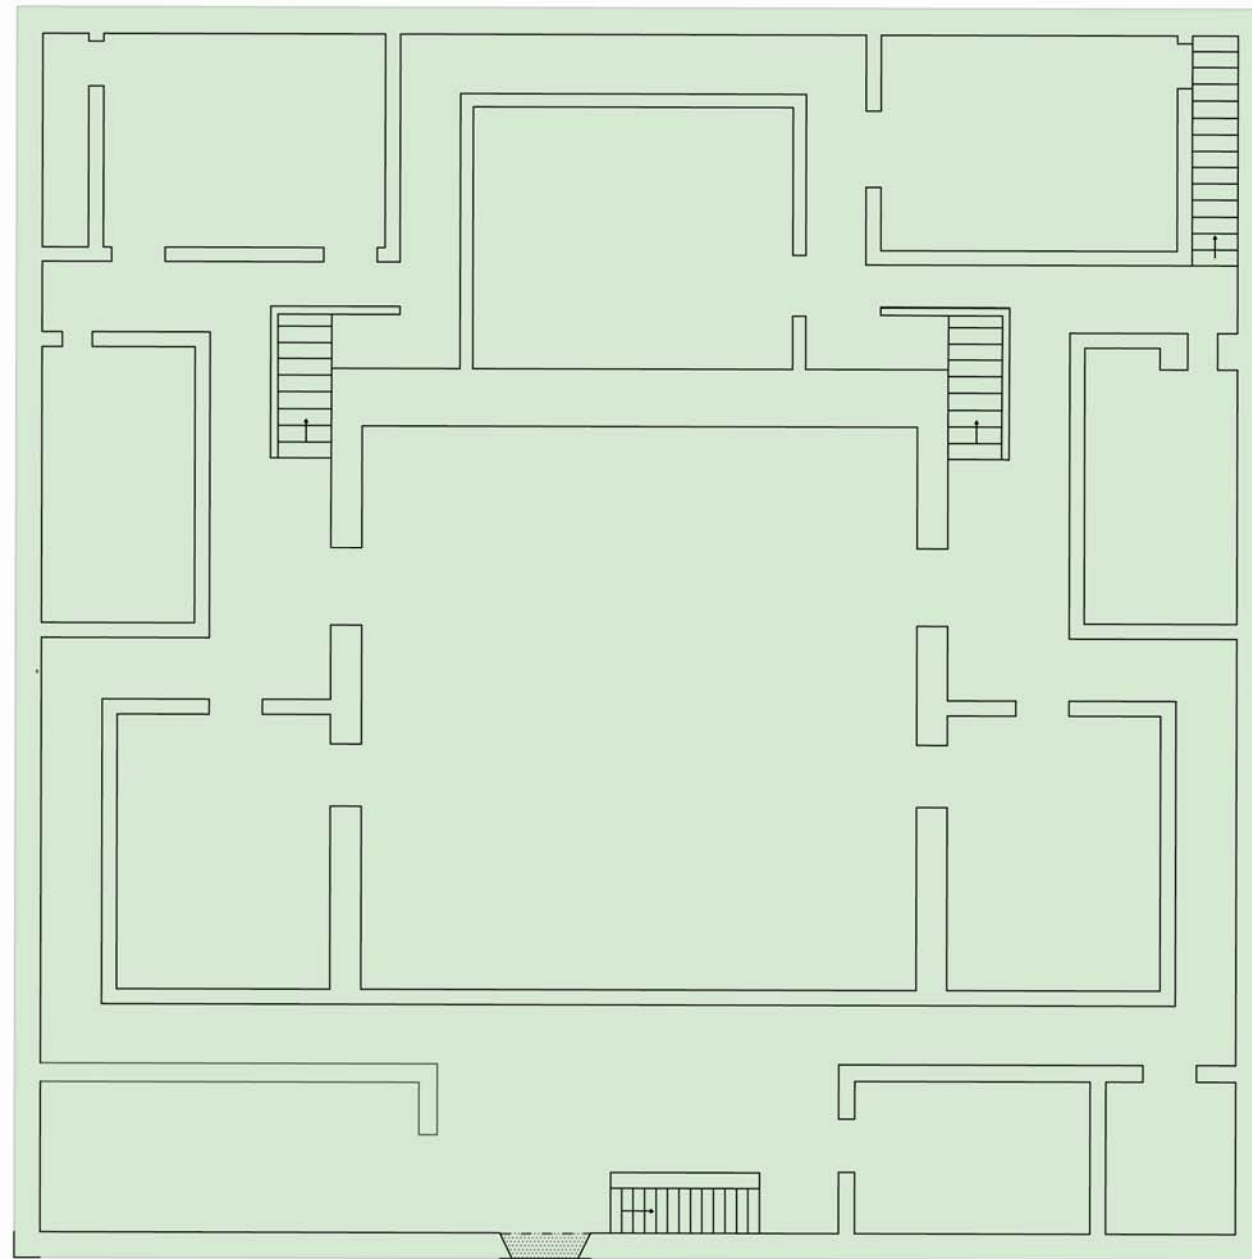
Centre for Applied Archaeology School of the Built Environment The Crescent Salford M5 4NW	Title: Bunker ground floor plan	Key: Blocked doorway/stairwells Mid 20th century original layout	
Site Name: Worsley New Hall Site Code: WNH-11 Drawing Ref: BS-WNH-11-7 Date Drawn: 28.11.11 Drawn By: MB	Scale:

Two main phases of activity at the concrete bunker were identified by the current survey. These indicated a building development spanning the 1950s to the 1990s (**Figs 7 & 8**).

This primary phase saw the construction of the two story concrete building as described in the documentary evidence from 1952. This building was erected as an Anti Aircraft Operations Room which served the Manchester Gun Defended Area (Catford, 2002, 1). On the ground floor, eight reinforced concrete rooms were constructed around the central operations room G4. The ground floor rooms included the radio communications room G2, the safe room G9, the boiler room G11 and the central ventilation room G12. The first floor comprised six rooms and one corridor (F1-F7) running around the edge of the central operations room. The viewing gallery F5 was located in the north of the building overlooking the central operations room through a viewing window from the north. Rooms F2, F7 and F1 were found to have blocked doorways located along those walls that bounded the central operations room. Corridor F4 was found to terminate at two open doorways located along the southern wall of the same room. It is suggested that a walkway originally ran around the circumference of G4 with access to the first floor via these openings. It is envisaged that this walkway provided access between G4 and the first floor. This notion is further supported by the presence of beam slots running around the edge of G4 at first floor height.

Despite the transfer of use of the site to Salford City in 1961 and then to the Greater Manchester Fire Service in 1974, no major alterations to the plan-form of the building were noted until the 1990s when it was sold to a local gun club. This phase saw the re-use and alteration of at least three rooms on the first floor. Rooms F1 and F7 were clearly re-used as long-range (F1) and short range (F7) shooting galleries. There is a possibility that during the building's use as anti aircraft operation building, these rooms were originally divided into smaller rooms. The local gun club who took over the building in the 1990s may have knocked the rooms together to create the long shooting galleries. The survey noted the construction of a butts and target practice area at the east end of F1 and at the south end of F7. Again these changes can be associated by the acquisition of the bunker by a local gun club in the early 1990's. Room F6 was found to contain three toilet cubicles constructed from breeze blocks. The main walls of the room were found to be constructed from reinforced concrete slabs and were clearly part of the original building. The cubicles were probably constructed during this phase as part of the conversion for use by the local gun club.

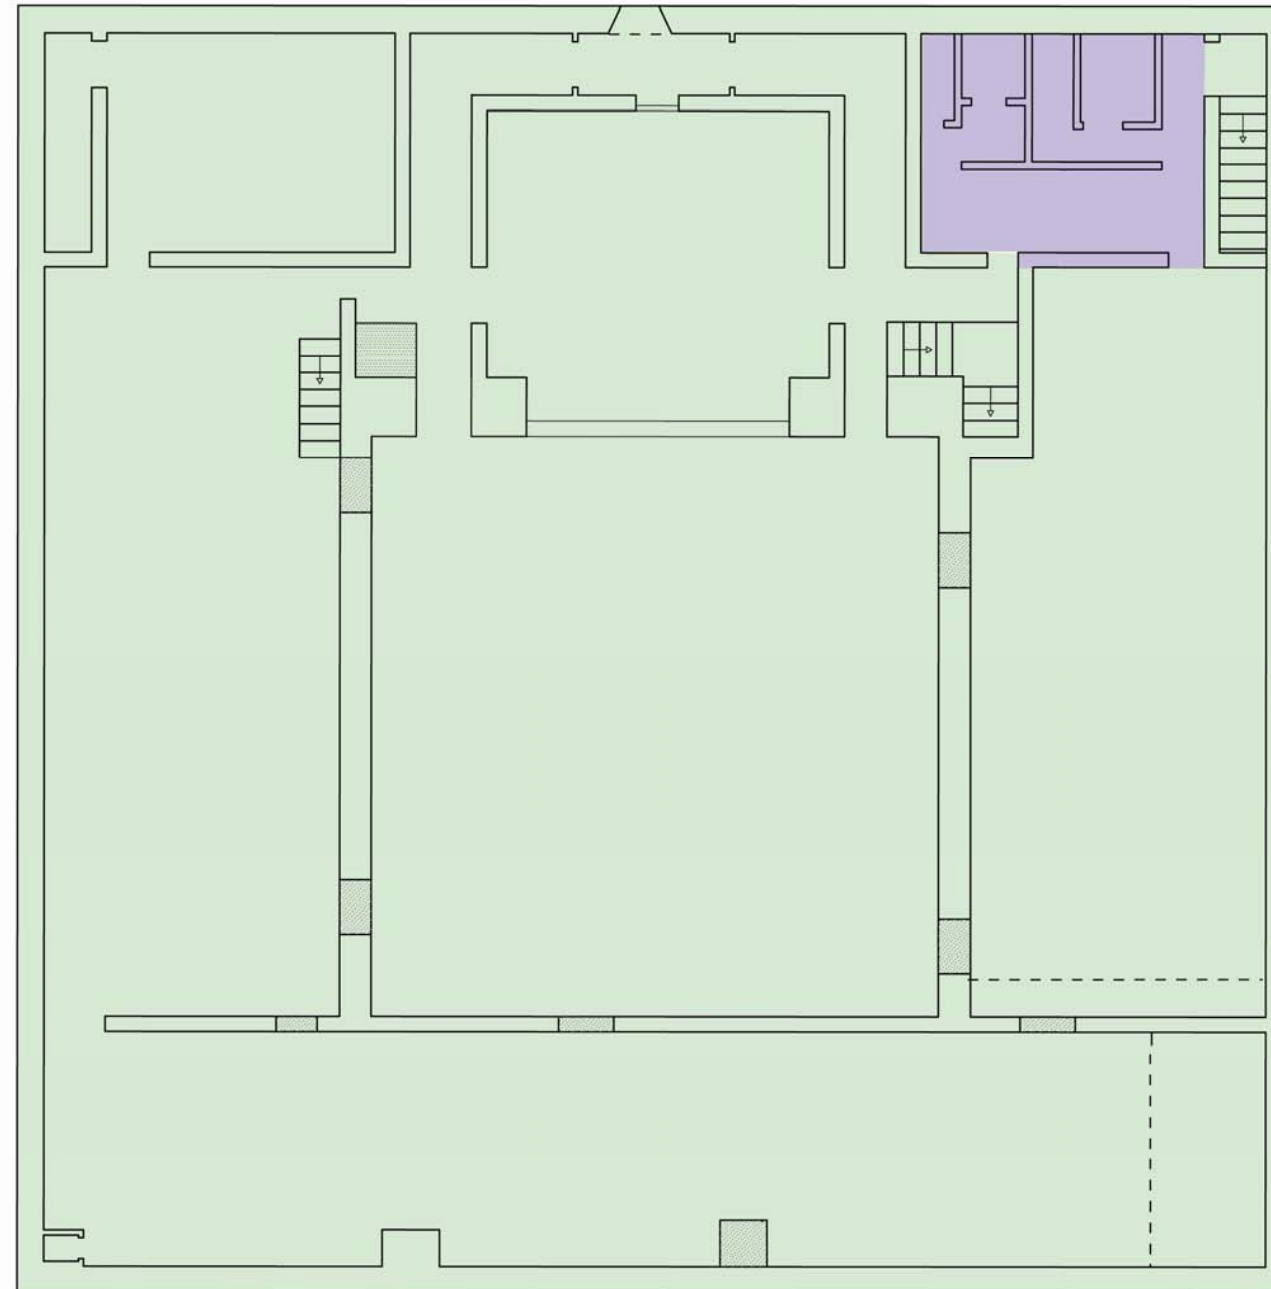
Centre for Applied Archaeology School of the Built Environment The Crescent Salford M5 4NW	Title: Bunker first floor plan phasing	Key: - - - - - Curtain wall for firing range Blocked doorway/stairwells Mid 20th century original layout Late 20th century alterations	
Site Name: Worsley New Hall Site Code: WNH-11 Drawing Ref: BS-WNH-11-8 Date Drawn: 28.11.11 Drawn By: MB	Scale: 0 5m

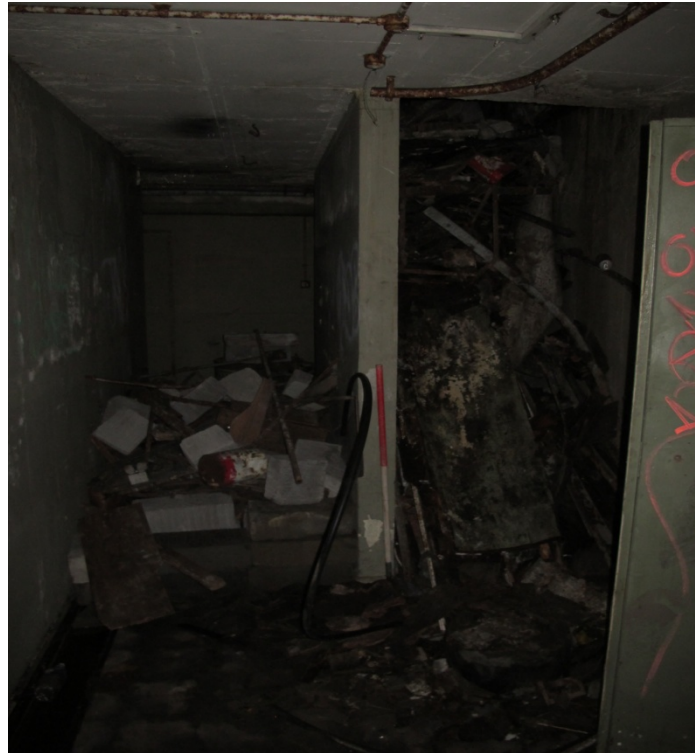
Figure 9: General shot of corridor G1 with blocked staircase S2 to the right. Looking north.

This room ran throughout the ground floor of the building providing access into all rooms on this level. G1 measured 1.20m wide and approximately 2.50m in height. The floor, walls and ceiling were constructed from reinforced concrete slabs. Iron piping and ventilation trunking ran round the top of the walls throughout the corridor.

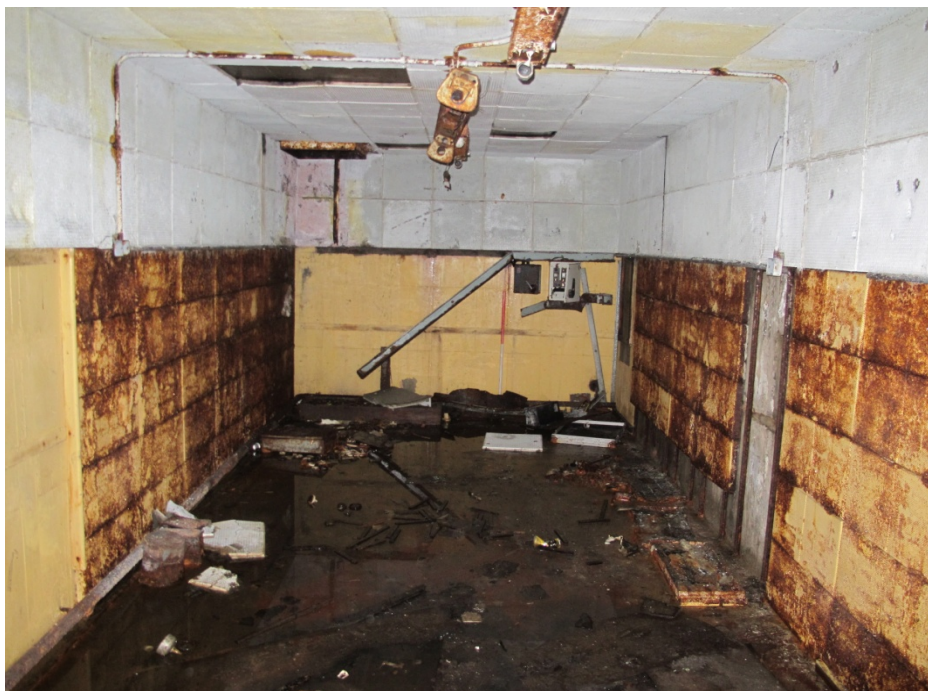
Figure 10: General shot of southwest radio control room G2 with sound proofing tiles covering the walls and ceiling. Looking west.

This room lay in the south-western corner of the building. The ceilings and walls were entirely covered in square asbestos tiles, which probably acted as a sound-proofing system. The floor was constructed from concrete. At the western end of the room were two wall-mounted boxes containing possible fuse boxes. These boxes were linked to an aluminium bar also mounted on the western wall. Two ceiling lights and associated switches were located in the central portion of the room. A possible iron air vent built into the ceiling was identified in the south-western corner of the room. The sound proofing tiling indicated that this was a radio/communications room.

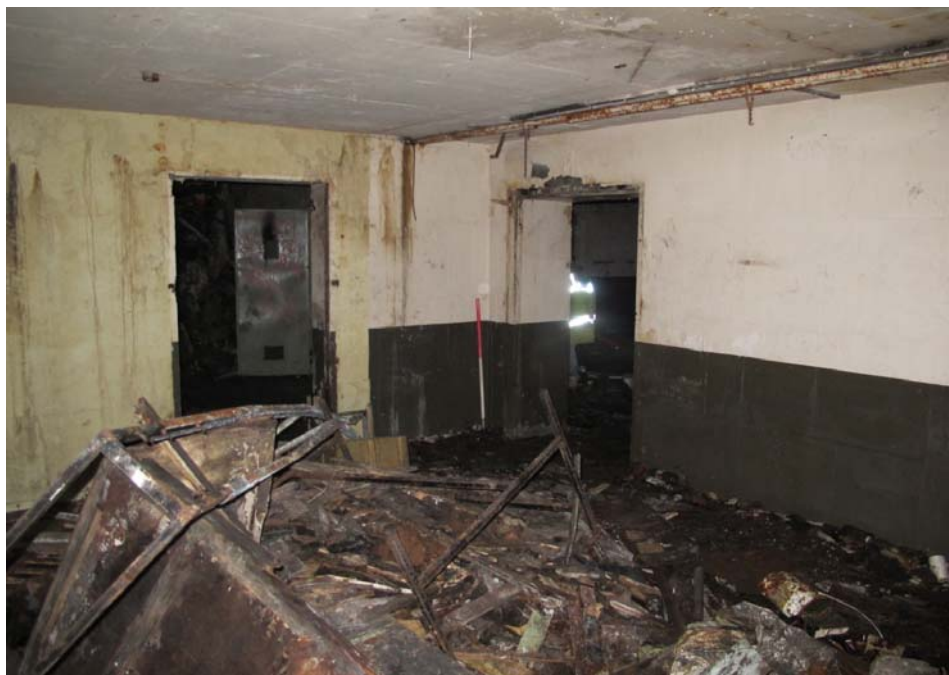
Figure 11: General shot of western room G3, showing the northern and eastern doorways. Looking northeast.

This room lay in the south-western portion of the building. Access to G3 was from corridor G1 to the south and from the central operations room G4 to the east. The room measured

4.27m x 5.50m. The floors, ceilings and walls were constructed from reinforced concrete slabs and covered in square tiling. No other features were present in this room.

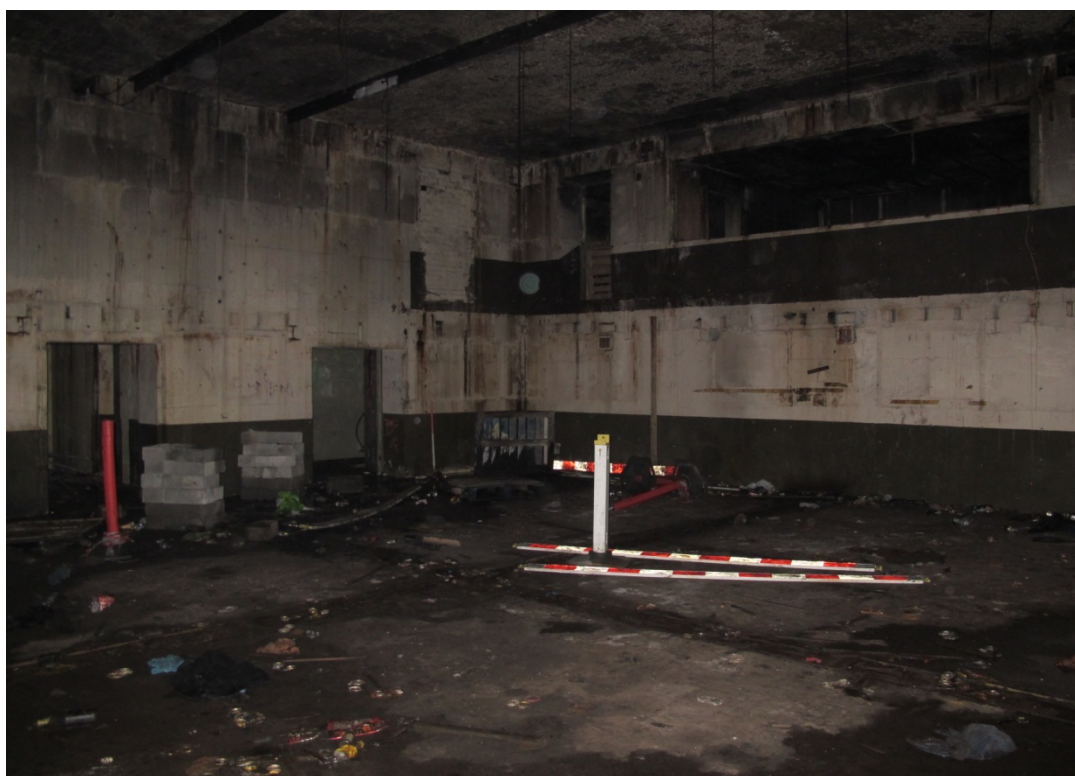
Figure 12: General shot of the main operations room G4 showing its western access points. The shot also shows the viewing gallery F5 on the first floor. Looking north-west.

This was located in the central portion of the building. G4 was the largest room in the building measuring 10.43m x 10.97m. The room had four points of access; from the west through corridor G1 and room G3 and from the east through corridor G1 and room G10. The viewing gallery (G7) located above the room to the north clearly identified this space as the main operations room. The walls, ceiling and floors were constructed from reinforced concrete slabs. Across the ceiling laid east to west were metal lighting strips and the remains of electrical cord that would have originally carried overhead lights. Strips of metal were also found on the walls (**Fig 13**). These were probably used as a mounting for shelves or cabinets. At least four blocked doorways were identified running around the top of G4 at first floor height. These doorways would have originally led to rooms F2 and F7 on the first floor. Two open doorways at the same height were also identified located either side of the viewing gallery in F5. These access points infer that a spectator's gallery originally ran over or around the top of the operations room with access to both G4 and the various first floor rooms. This notion is supported by the presence of beam slots running around the circumference of the room at the same level. The room was found to be full of debris from all periods.

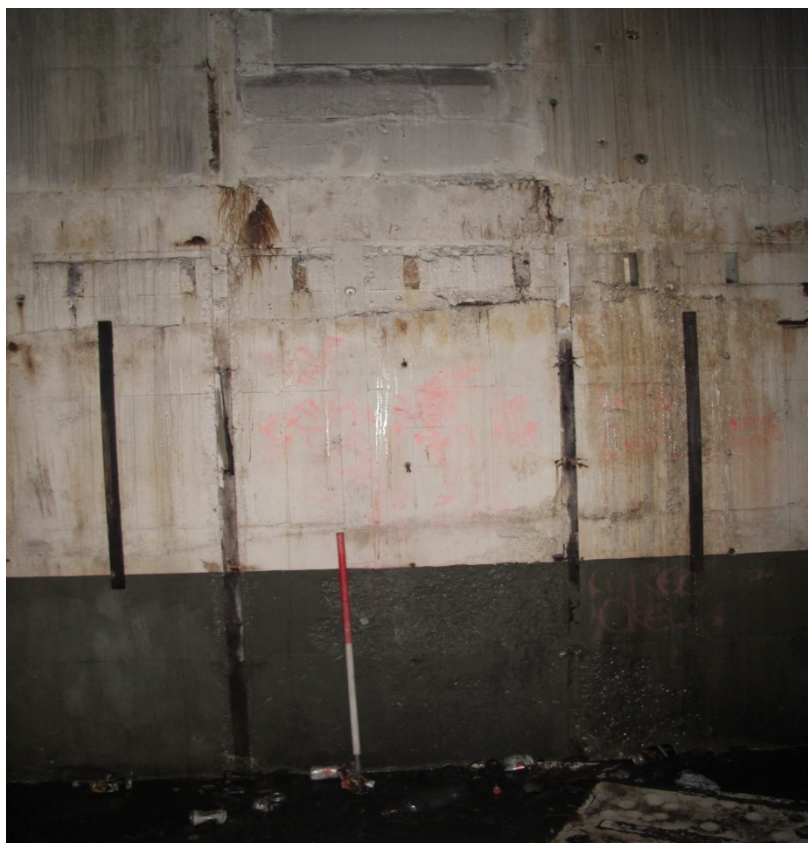
Figure 13: Detail of fixings for possible shelving on the east facing wall of the main operations room G4. Looking west.

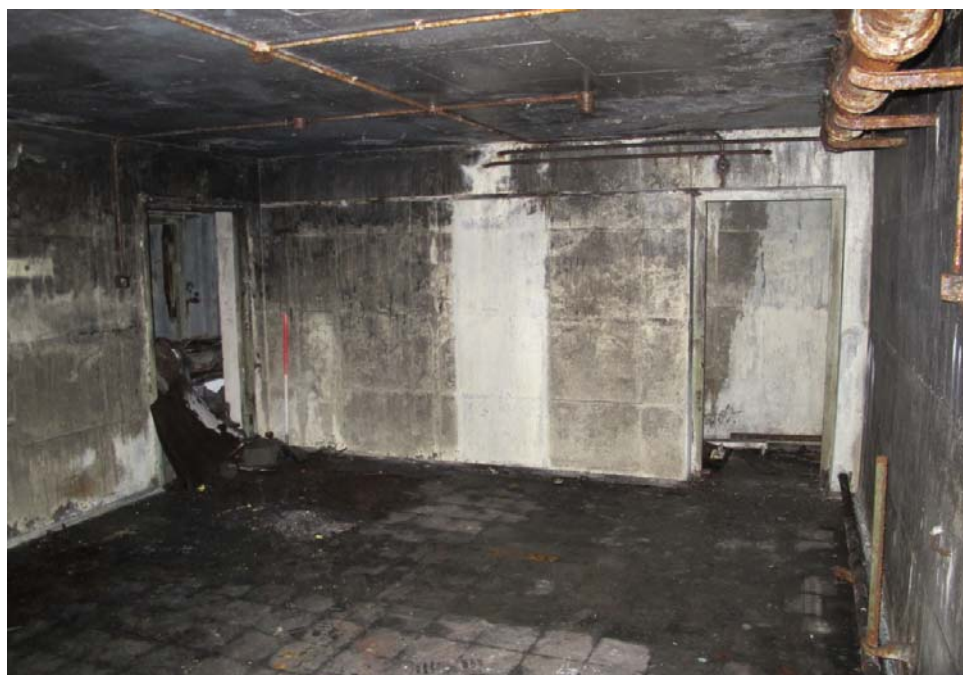
Figure 14: General shot of north-western room G6, showing the southern doorway and access to the western side room. Looking southwest.

This lay in the far north-western corner of the building. The room measured 5.64m x 4.57m. The floors, walls and ceiling were constructed from concrete. Iron pipes and light fittings ran at ceiling level across the extent of the room. No other fixtures or fittings were present. G6 could be accessed from two doorways along the room's northern wall, both of which led into corridor G1. At the western end of G6, a doorway led into a narrow side room measuring 3.20m x 0.92m. The only access into this room was through G6. This side room was void of any fixtures and fittings.

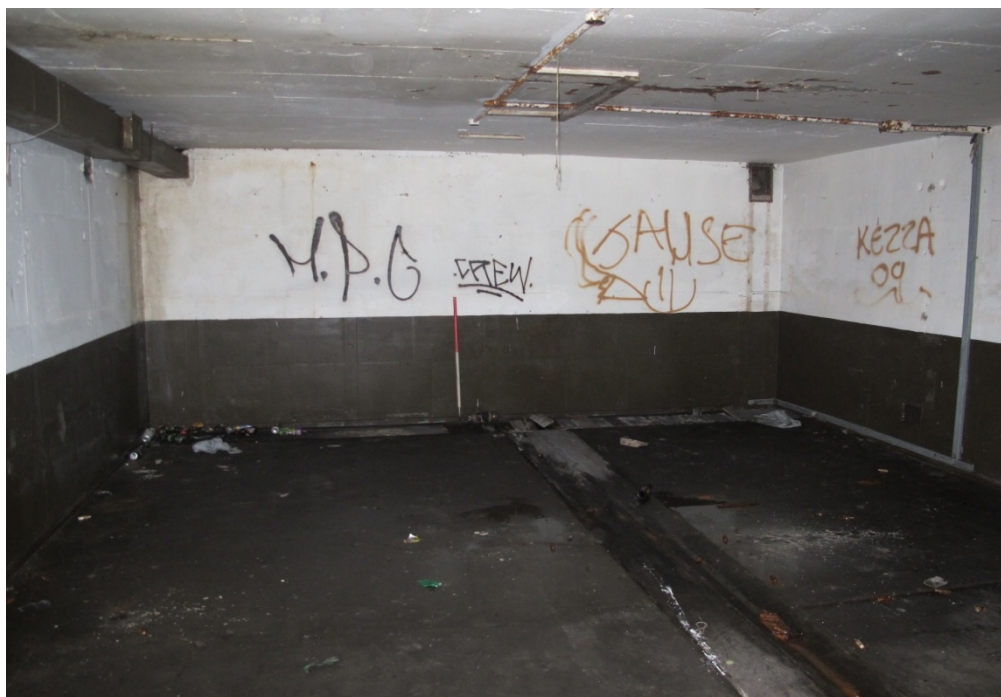
Figure 15: General shot of room G7, showing the floor with a 'T-shaped' wooden in-lay. Looking west.

This room was located in the southern central portion of the building. The room measured 6.40m x 5.71m. The floor, walls and ceilings were constructed from reinforced concrete slabs. Light fittings ran at ceiling level. An air vent system ran along the top of the northern wall. A 'T-shaped' wooden inlay ran north-south across the main floor of the room. A groove running down the centre of this wooden inlay suggested that this feature was a runner for mobile shelving or screens.

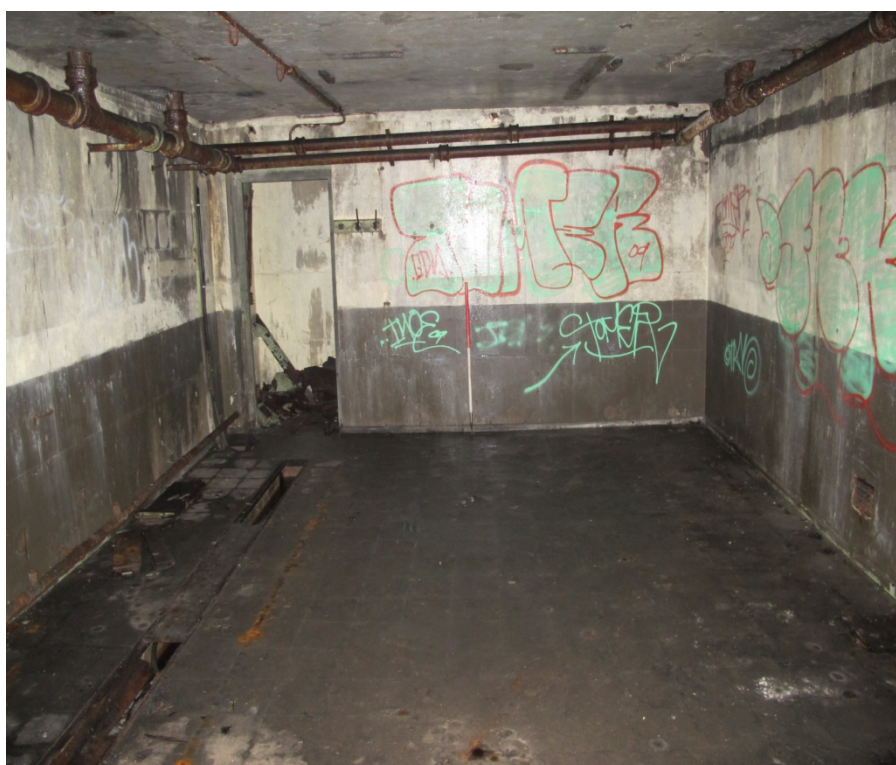
Figure 16: General shot of room G8, showing doorway leading to staircase S4. Looking east.

This lay in the far north-eastern corner of the building, and was a mirror image of room G6. The room measured 5.64m x 4.57m. The room could be accessed from the west through a

1.52m wide doorway from corridor G1. At the eastern end of G8, a doorway led into a narrow side room. This room measured 3.20m x 0.92m. A likely use of this space would be for storage purposes. Iron heating pipes and light fittings ran around the top of the room at ceiling level. At the eastern end of the room, the remains of three wall mounted iron coat hooks (**Fig 17**) were found to the south of the doorway leading to the side room.

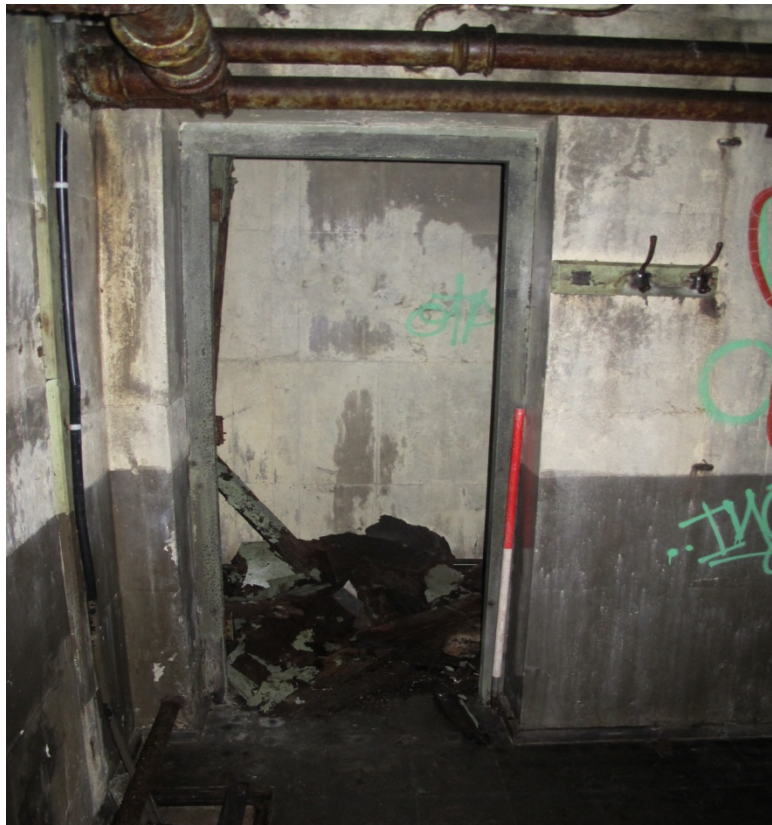
Figure 17: Detail of doorway in room G8 leading to staircase S4 showing wall mounted coat hooks. Looking east.

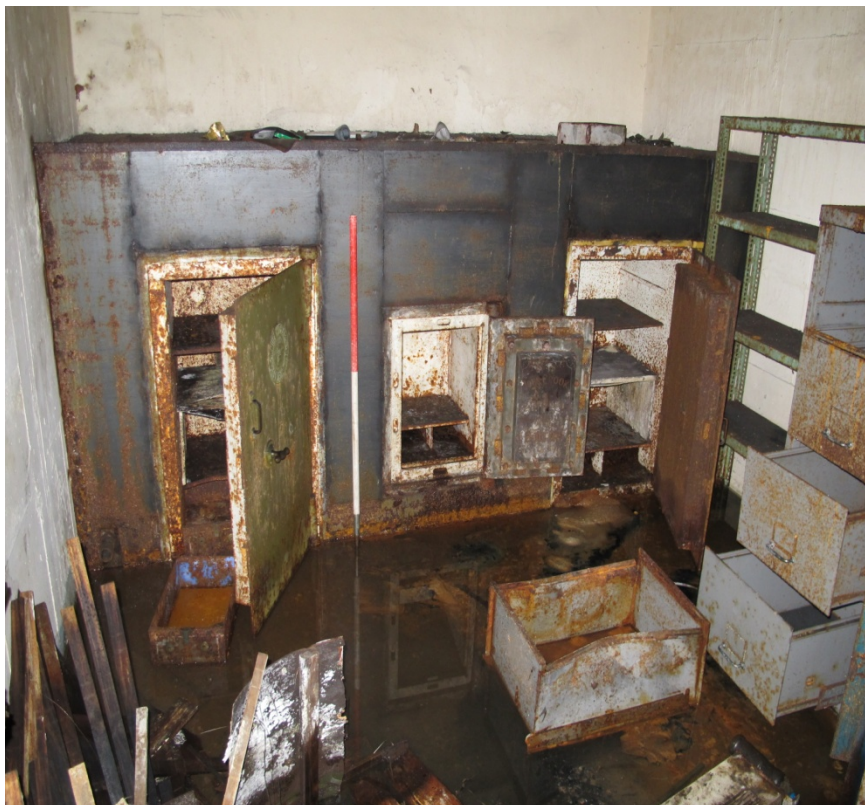
Figure 18: General shot of the safe room G9, showing the three cast iron and steel safes along the south wall. Looking south

This room lay in the eastern half of the building, directly opposite room G8 in the west half of the building. The room measured 5.50m x 3.05m. The only access into this room was from the north through a reinforced steel framed cast iron safe door. The door was painted gray and embellished with the maker's stamp on the inside of the door: 'Chatwood Milner Ltd, London, England' (**Fig 19**). Along the south wall of the room were three fitted cast iron/steel safes all of which were found to be empty and open. The eastern safe was embellished with the logo: 'Samuel Withers & Co, West Bromwich'. To the west of the safes, along the room's western wall was one set of steel shelving units. Adjacent to these units was a four tiered grey filing cabinet which were found open and empty. Next to the filing cabinet were two blue steel cabinets. Other shelving units were found lying on the ground amongst general debris.

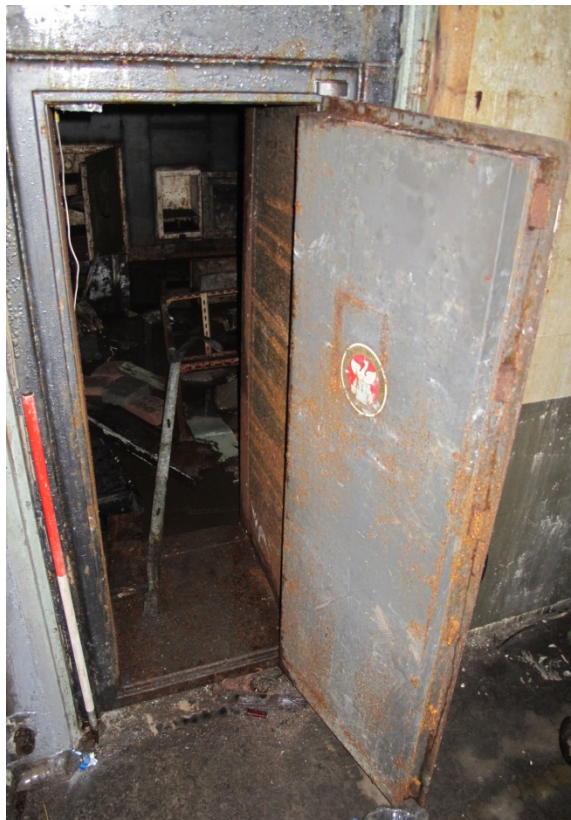
Figure 19: Detail of the main door into to the safe room G9. Note the reinforced steel surround and double thickness iron door. Looking south.

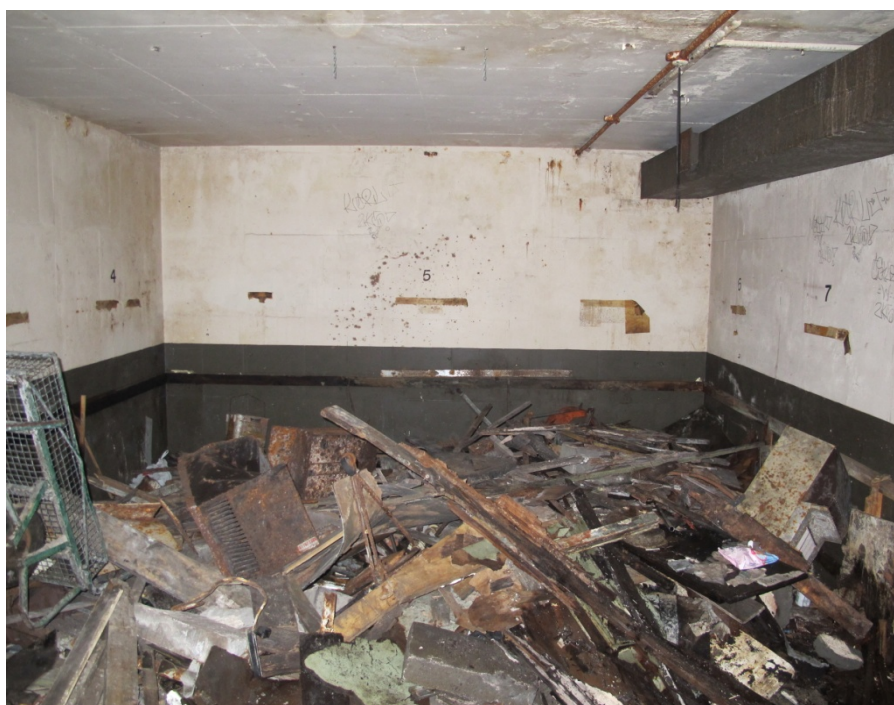
Figure 20: General shot of eastern room G10 partially filled with debris. Looking south.

This lay in the southeast portion of the building and was a mirror image of room G3. G10 measured 4.27m x 5.50m. The room could be accessed from the north via corridor G1 or from the west by the central operations room G4. A single strip of metal ran around the room at mid level. Light fittings and a ventilation shaft ran north-south across the room at ceiling level. The room was found to be full of debris.

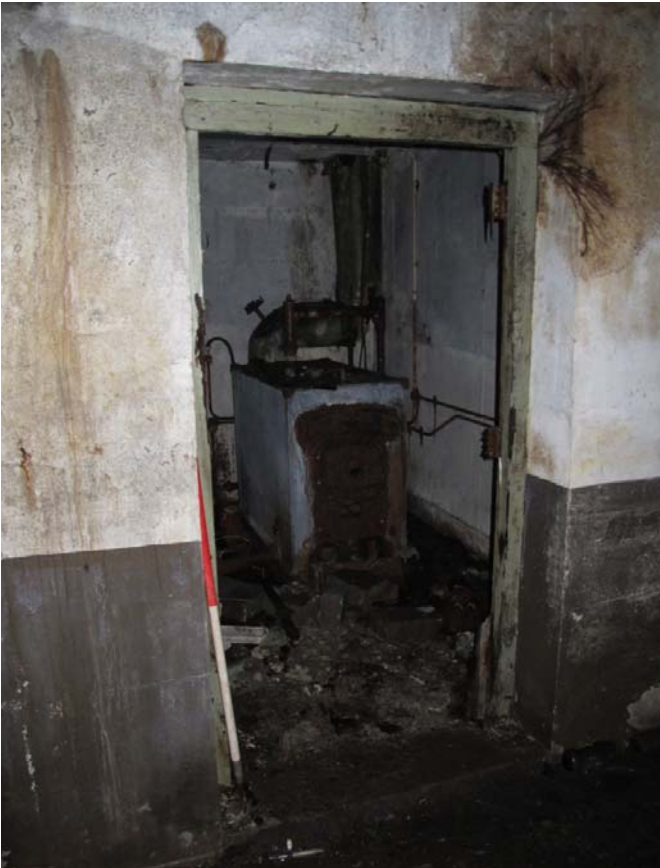
Figure 21: Shot of the northern doorway into the boiler room G11 from corridor G1. The boiler itself can be seen in the south-western corner of the room. Looking south.

This room was located in the far southeast corner of the building. The room measured 3.05x 2.60m and was accessible from the north by corridor G1. In the southwest corner of the room was a cast iron/steel boiler (**Fig 22**). Running from the back of the boiler up and through the ceiling was a flue. Various iron pipes ran off the east side of the boiler. Fitted to the east wall of G11 were the remains of two iron supporting bars, probably used to hold machinery associated with boiler (**Fig 23**). Various light fitting and control switches were found mounted to the west wall of G11 under an air vent.

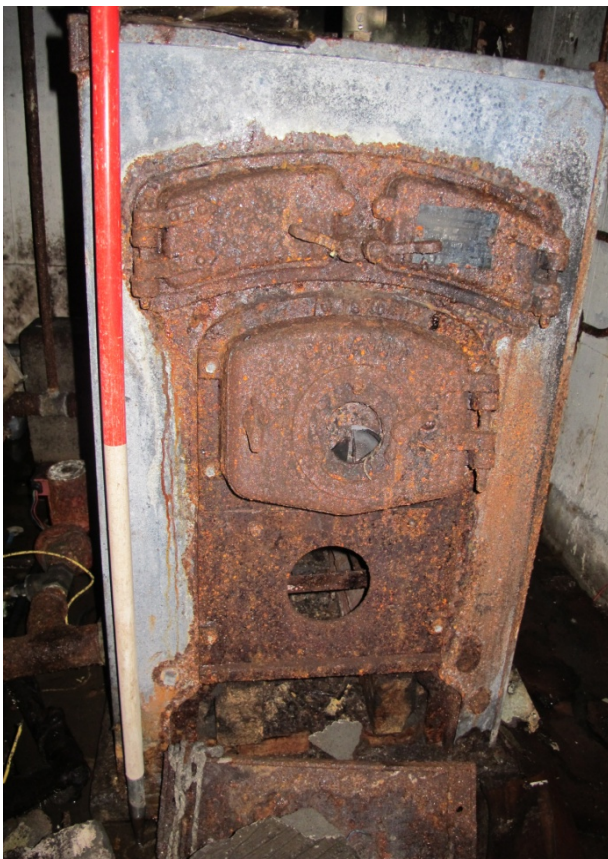
Figure 22: Detail of the cast iron boiler in room G11.

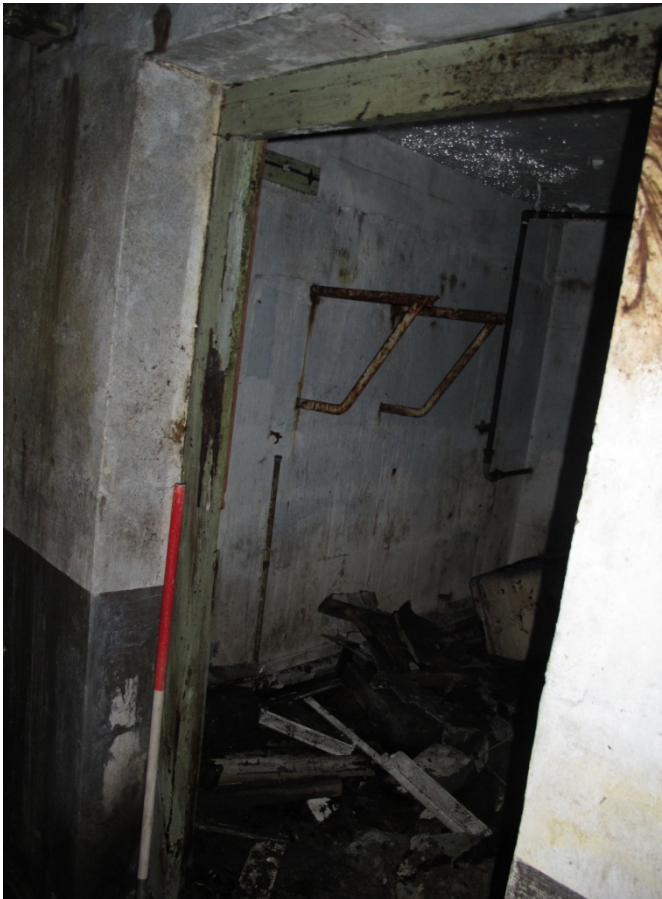
Figure 23: Detail of wall mounted support bars on the west facing wall of room G11.

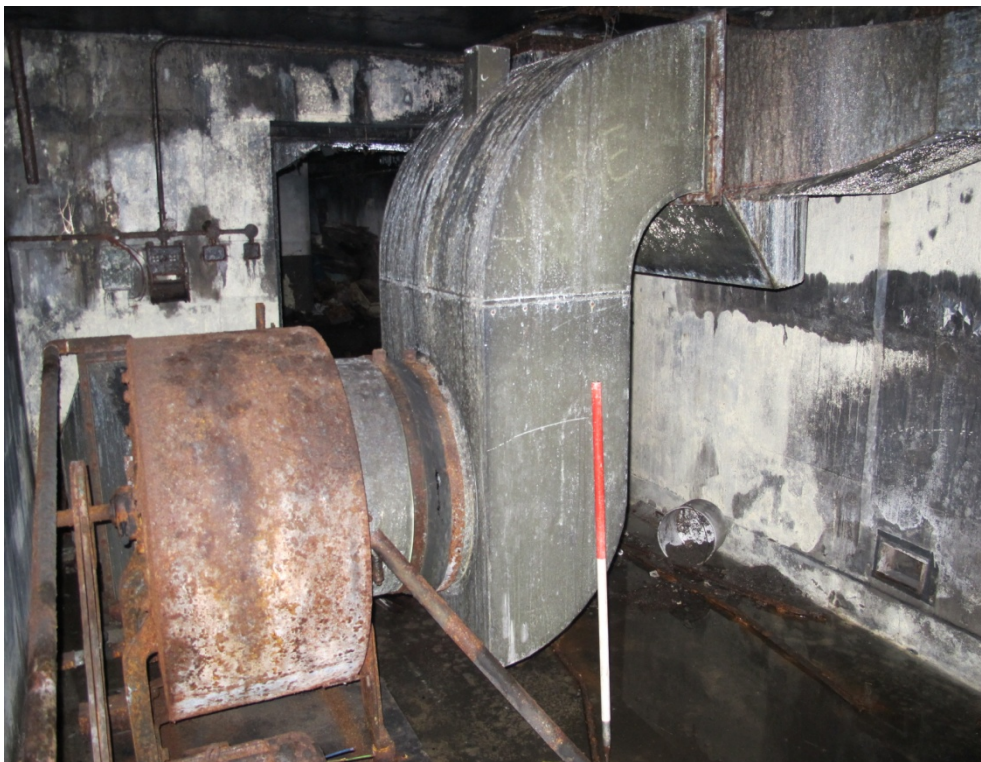
Figure 24: Shot of the air ventilation room G12, showing the central air handling unit for the building. Looking west.

This lay directly to the west of room G11. The room measured 4.71m x 3.06m and was accessible from the west by corridor G1. The room contained a large iron/steel air handling unit, the central component for the building's ventilation system. The controls for the system and the room's lighting were located on the western wall. An additional wall mounted control was located on the eastern wall (**Fig 25**).

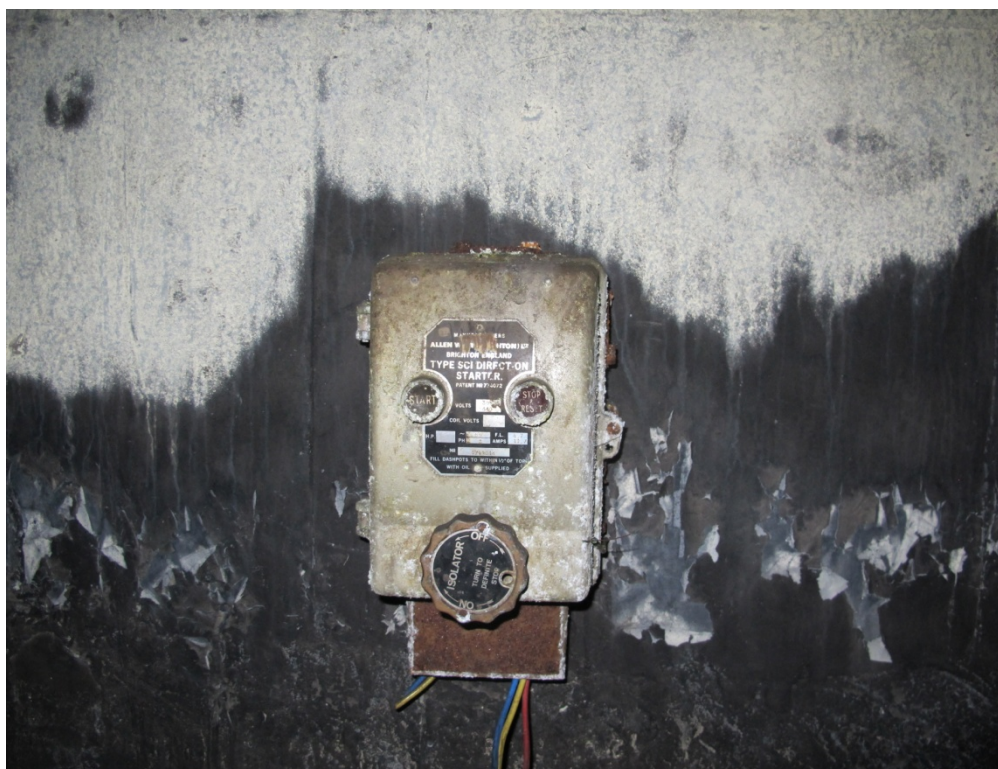
Figure 25: Detail of wall mounted control device for the ventilation unit in room G12. The device was fixed to the south facing wall of the room.

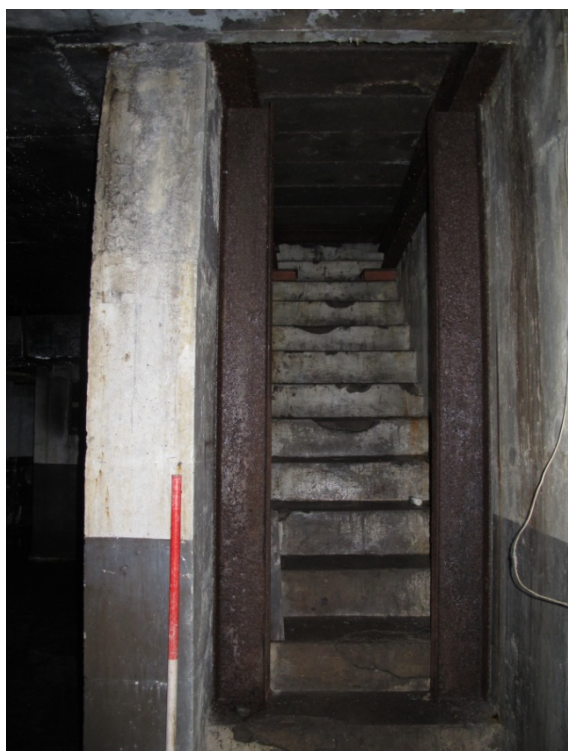
Figure 26: Detail of stairwell S1 which rose from corridor G1 to room F1 on the first floor. Access to F1 was found to be blocked by a wooden hatch built into the floor of F1.

Stairwell S1 (Fig 26) was located at the very south of the building. The stairs rose from an entrance flanked by two steel posts in corridor G1 to room F1 on the first floor. The staircase

was found to be blocked at the top of its flight by a wooden hatch laid into the floor of F1 (Fig 31)

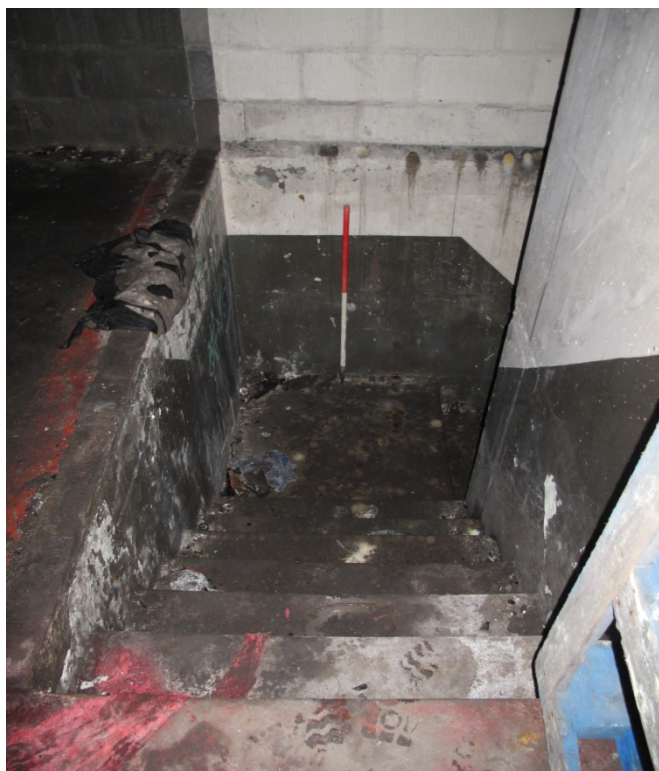
Figure 27: Shot taken of eastern stairwell S3 taken from corridor F4 on the first floor. Looking east.

Stairwell S3 (Fig 27) was located in the eastern half of the building. The stairs rose from corridor G1 to corridor F4 on the first floor. The stairs provided direct access to the viewing platform G7 on the first floor.

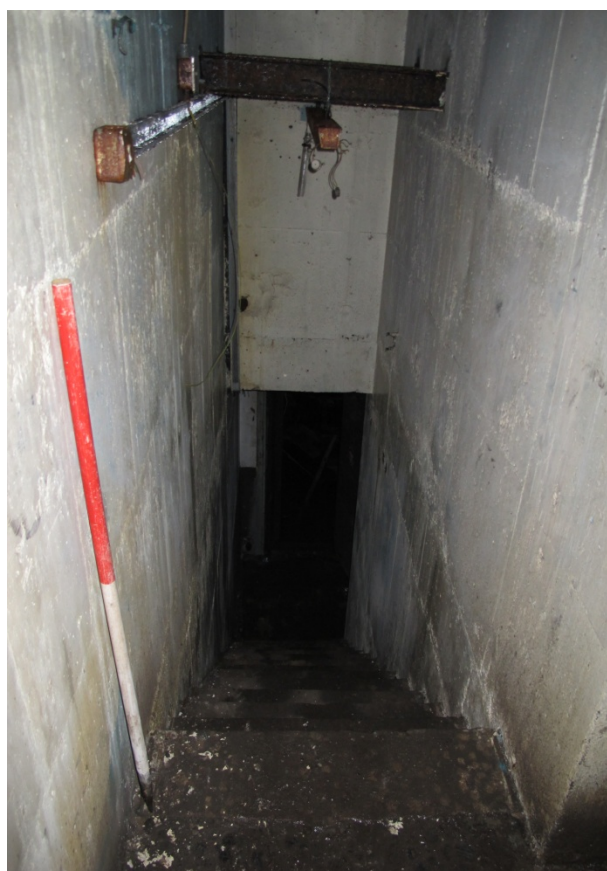
Figure 28: Shot taken of north eastern staircase S4, looking down the staircase from toilet room F6. Looking south.

Stairwell S4 (Fig 28) lay in the far northeast corner of the building. The stairs rose from corridor G1 on the ground floor to the toilet block in room F6 on the first floor.

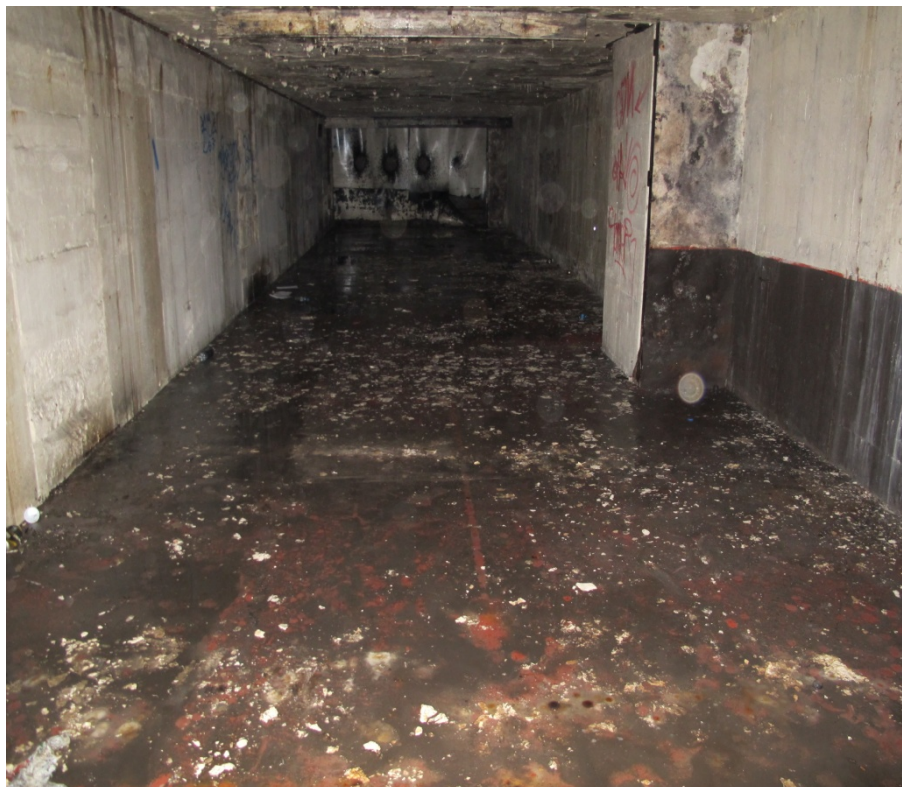
Figure 29: General shot of the long range shooting gallery in F1.

This room was located in southern part of the building. The room ran the full width of the building, along its southern external wall. F1 measured 21.70m x 4.60m. The floors, walls and ceilings were all constructed from reinforced concrete slabs. Access to F1 was from the west through a door in the northern partition wall. At the far western end of the room was a row of four shooting targets made from sheet metal. It is likely that these sheets originally lay behind superimposed circle targets. Behind the metal sheets was the 'butts' or backstop where the pellets used for shooting would have been contained and collected. A power control box was located on the room's western wall (**Fig 30**). Laid in to the floor, along the southern wall of F1 was a square wooden hatch (**Fig 31**). The hatch was found to block the top of stairwell S1.

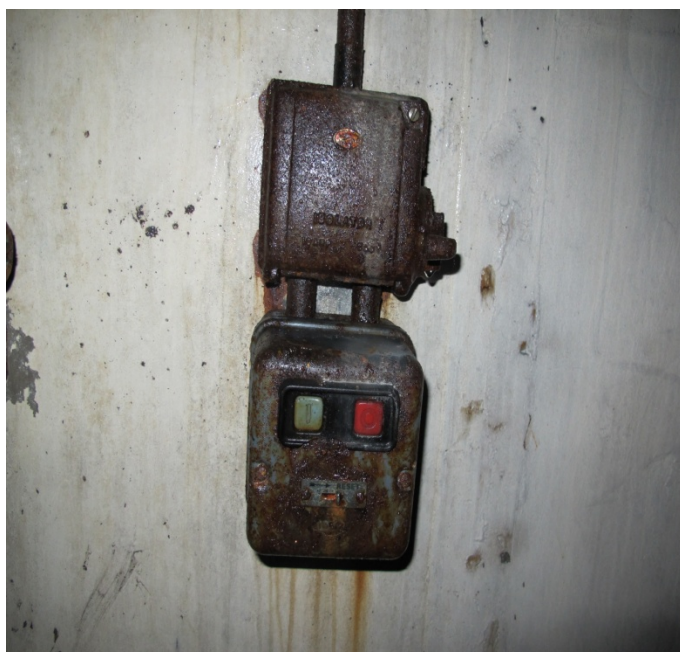
Figure 30: Detail of a power control system mounted on to the south facing wall of room F1. Looking north.

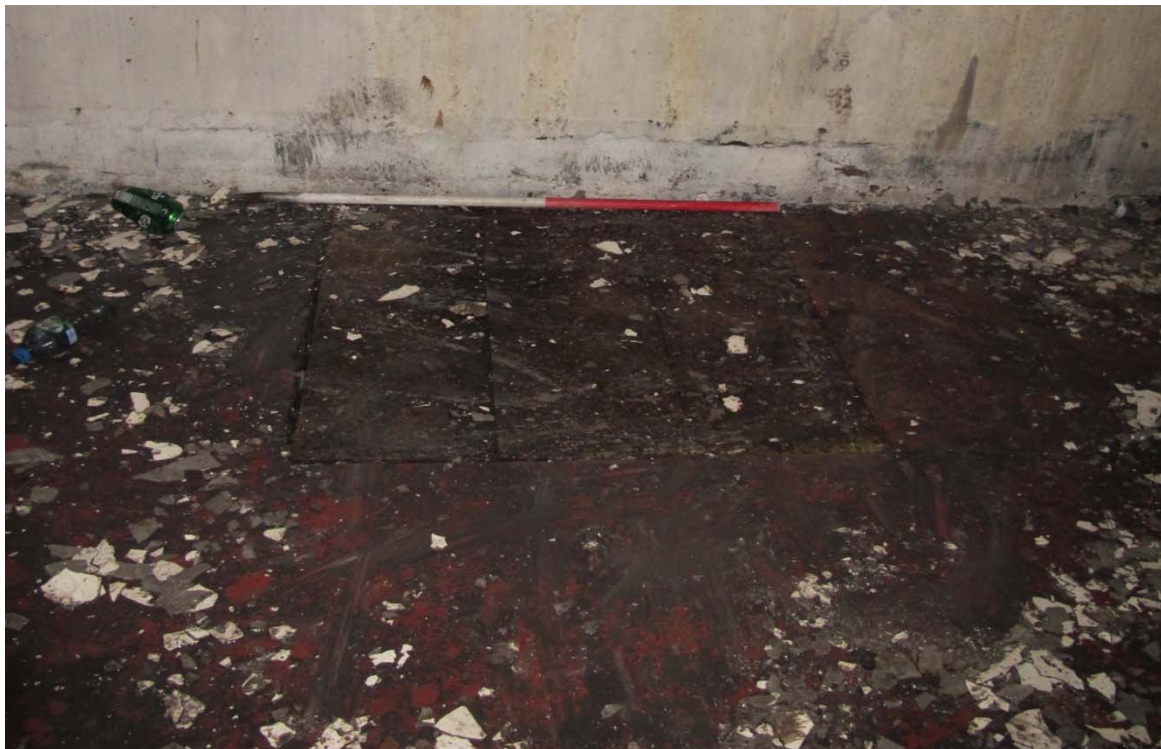
Figure 31: Detail of blocked southern stairwell S1 in room F1. The wooden hatch marks the location where the stairs would have risen to from corridor G1 on the ground floor.

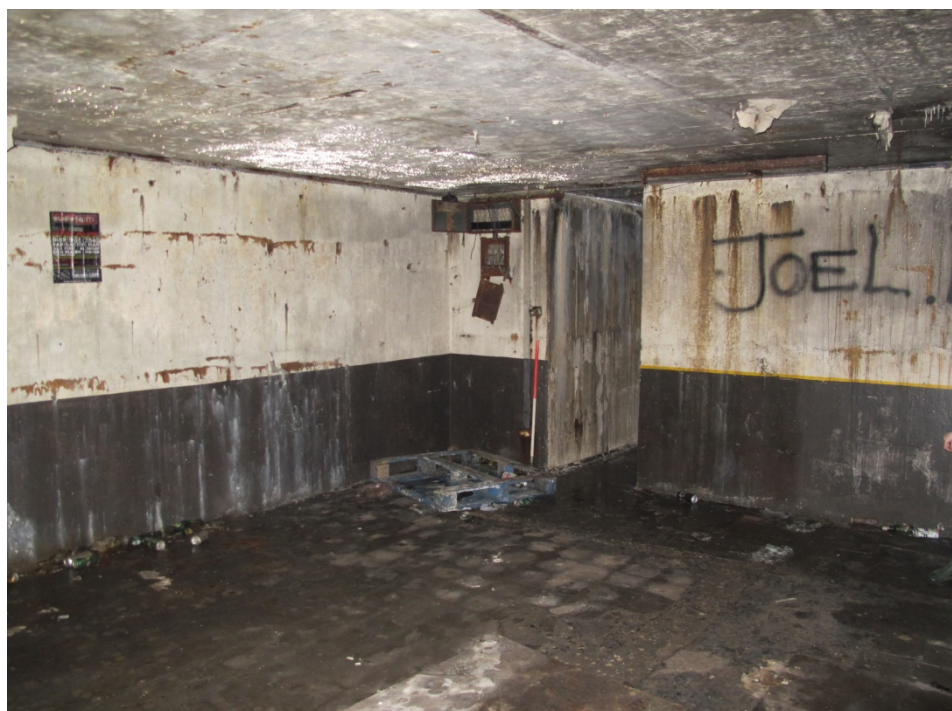
Figure 32: General shot of room F2 showing the access to room F3 along the northern wall and a series of possible fuse boxes in the northwest corner of the room. Looking northwest.

This was located in the western portion of the building, aligned north-south along the western exterior wall. The room measured 14.35m x 5.80m. The floor and walls were constructed from concrete. F2 could be accessed from the south through room F1, from the north by room F3 and from the east by corridor F4. Two blocked doorways were identified along the room's eastern wall (**Fig 33**). On the north wall were two wall mounted fuse boxes.
