**Archaeological
Building Survey:**

Worsley New Hall
Cold War Bunker,
Worsley. Final
Version.

Client: Peel
Investments (North)
Ltd.

Report No: 02/2012

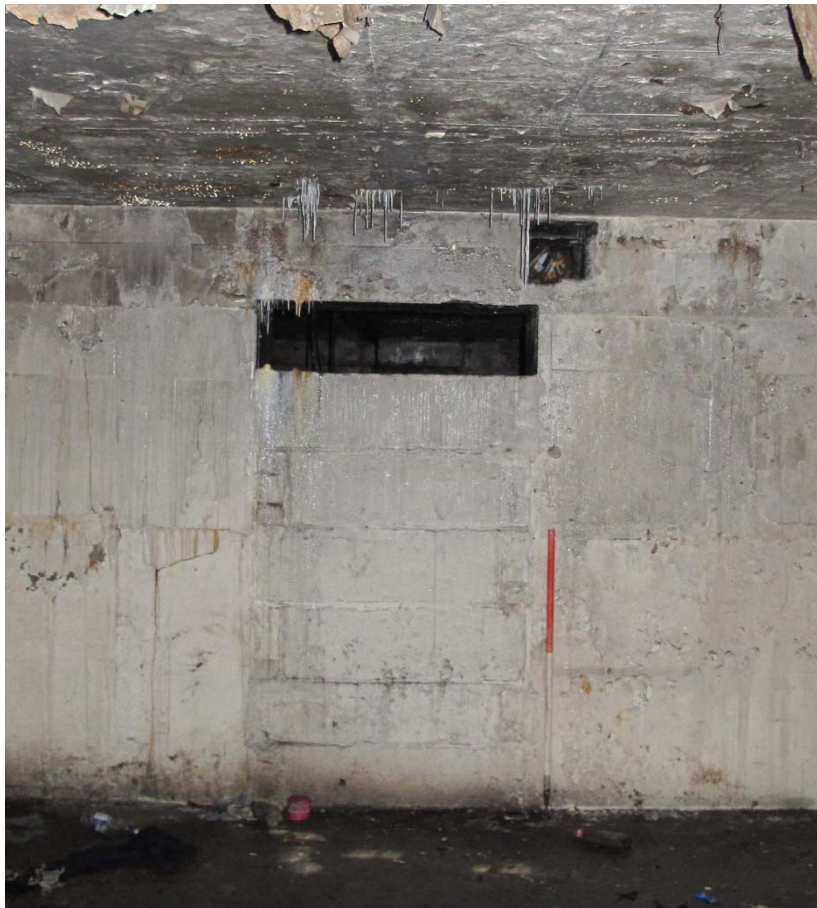
Figure 33: Detail of the most southerly blocked doorway along the east wall of room F2. This doorway would have originally lead to a walkway or room that ran around the top of the main operations room G4. Looking east.

This was located in the western portion of the building, aligned north-south along the western exterior wall. The room measured 14.35m x 5.80m. The floor and walls were constructed from concrete. F2 could be accessed from the south through room F1, from the north by room F3 and from the east by corridor F4. Two blocked doorways were identified along the room's eastern wall (**Fig 33**). On the north wall were two wall mounted fuse boxes.

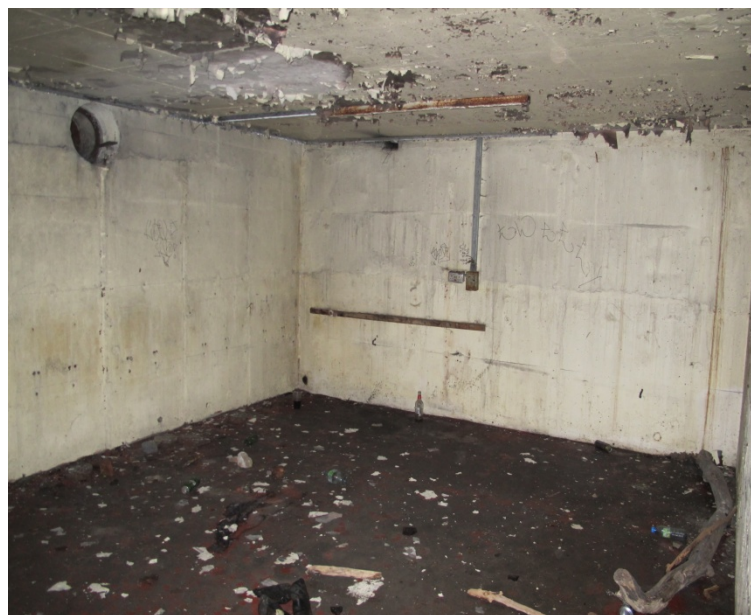
Figure 34: General shot of room F3 showing light switch on the north wall and an open air vent cut through the west wall. Looking north.

This room lay directly to the north of room F2 and could only be accessed from this room. F3 measured 4.26m x 5.77m. All walls were built with breeze blocks and coated with a white-wash paint. An open circular air vent leading outside the building had been cut in to the north wall. Two sets of wall mounted light switches were identified on the east wall. A 1m wide

doorway located in the northwest corner of the room lead into a rectangular side room measuring 3.00m x 1.00m. At the time of this survey this room was full with debris.

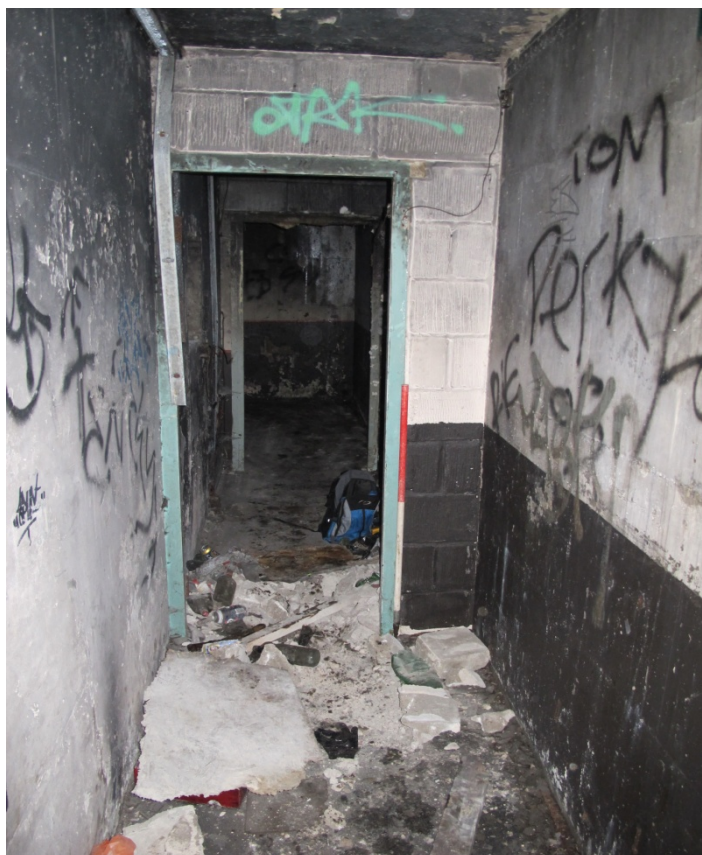
Figure 35: General shot of corridor F4 looking west down the east-west aligned section of the corridor.

This lay in the northern part of the building and was found to run around the viewing platform area F5. The corridor provided access to eastern room F2, the viewing platform F5, and the toilet block F6. Staircase S3 rose to meet F4 from the ground floor. The corridor appears to terminate either side of the viewing gallery at two open doorways that drop straight down to the operations room on the ground floor (**Fig 36**). The corridor was found to be constructed from concrete blocks which had been painted black from their mid section down to the floor. The north-east aligned section of F4 was found to have a small square window cut through its southern wall into the north wall of the viewing platform room (**Fig 37**). A single strip of metal had been laid round the ceiling of the corridor. It is presumed this was for mounted ceiling lights.

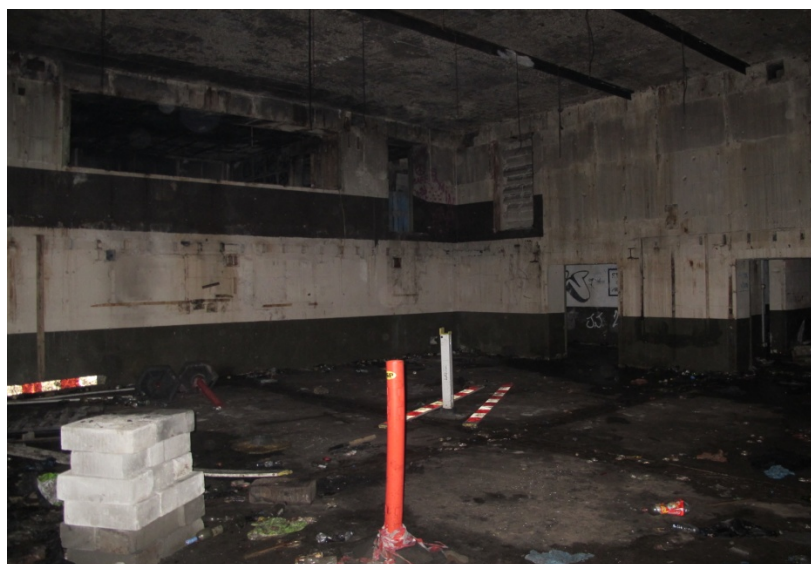
Figure 36: General shot of the main operations room showing the eastern end of corridor F4 terminating with an open doorway on the first floor. Looking northeast.

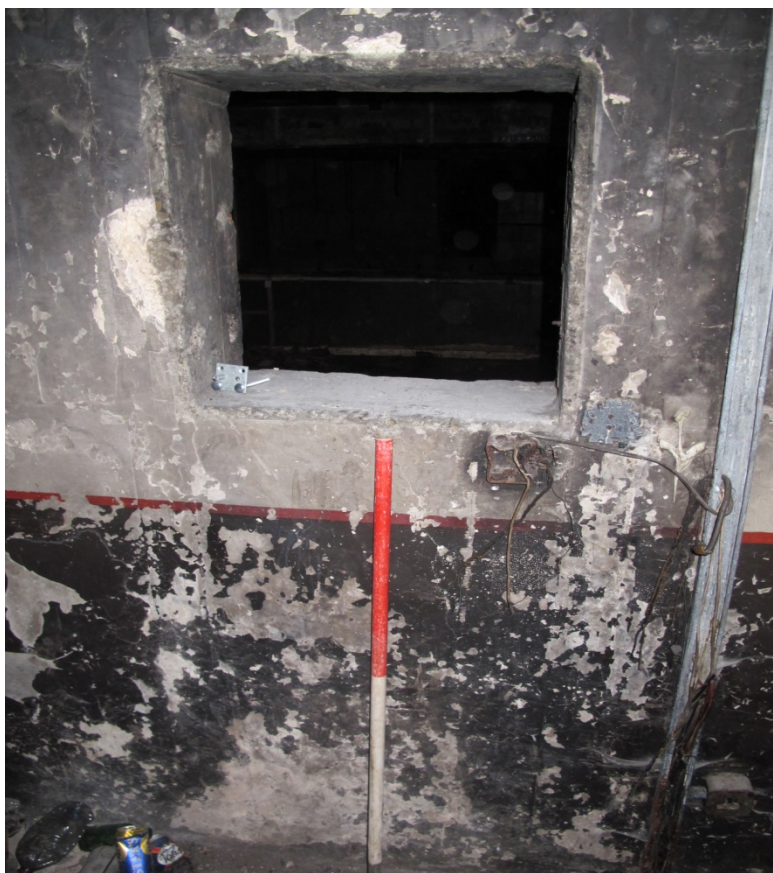
Figure 37: Detail of a window cut into the partition wall between corridor F4 and the viewing gallery room F5. Looking south.

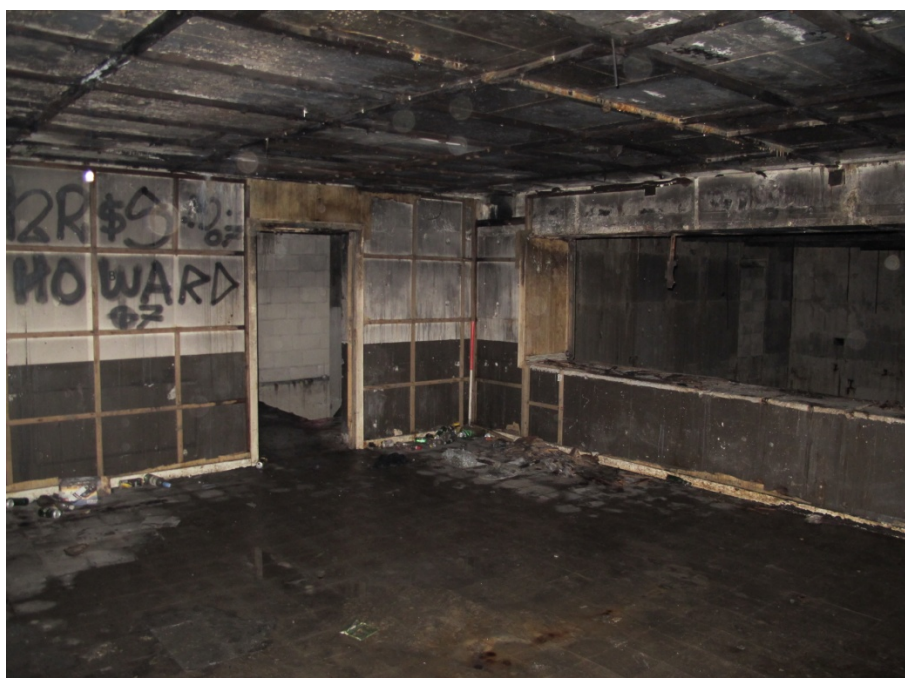
Figure 38: General shot of the viewing gallery room F5 showing the eastern doorway and the viewing window that looks down on to the main operation room G4. The walls and ceiling were found to be covered in wooden framing, a likely mounting for wooden panels. Looking southeast.

This room lay in the northern part of the building and was partially surrounded by corridor F4. The room measured 6.42m x 5.48m. The southern wall of the room was made from solid concrete and was partially open. This opening provided the building with a large viewing gallery for the central operations room (G4) that lay below on the ground floor. The northern, eastern and western walls were constructed from breeze blocks. Covering the extent of these three walls and the ceiling were the remains of wooden frames, very likely to have been a mounting for wooden panels. Access to this room from G4 was through two doorways in the northeast and northwest of F5. Staircase's S2 and S3 provided access to the viewing gallery from the ground floor.

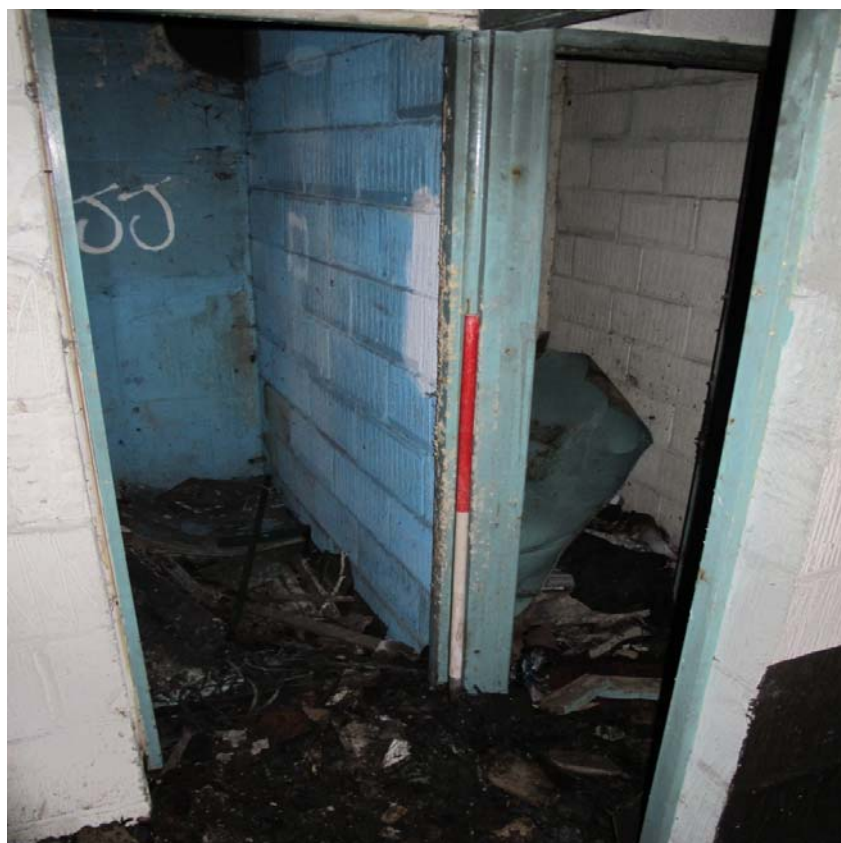
Figure 39: General shot of the breeze block toilet block in north-eastern room F6. Looking northeast.

This was located in the far north-eastern corner of the building. The room comprised of three breezed blocked south facing toilet cubicles. There were three points of access to this room: two to the north by corridor F4 and room F7 and one to the west by staircase S4 which rose to F6 from the ground floor. A metal fan probably associated with the air venting systems was found running through the mid section partition wall in room F6 (**Fig 40**). It was clear that the toilets were a later addition and the room would have originally been an open space, mirroring the image of room F3 in the north-west corner of the building.

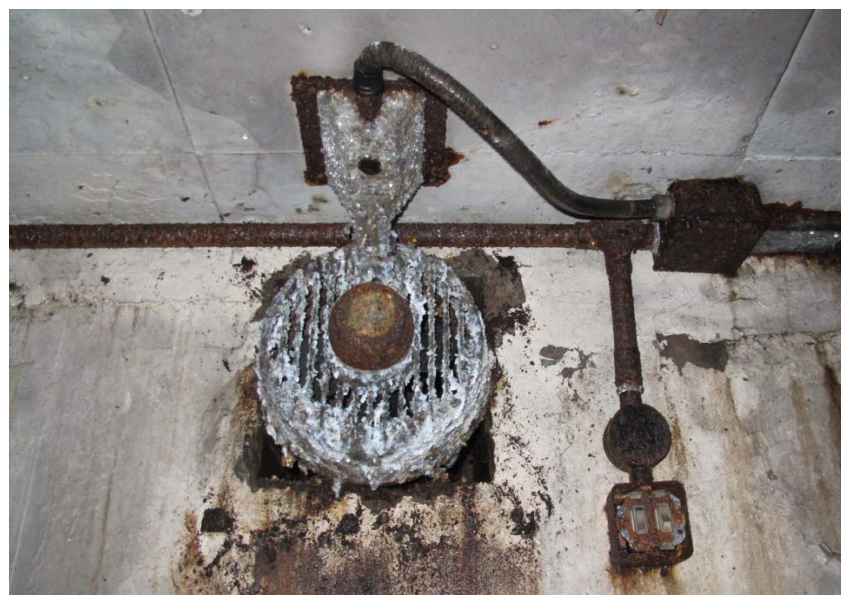
Figure 40: Detail of a corroded fan located on the east-west aligned partition wall in room F6. Looking north.

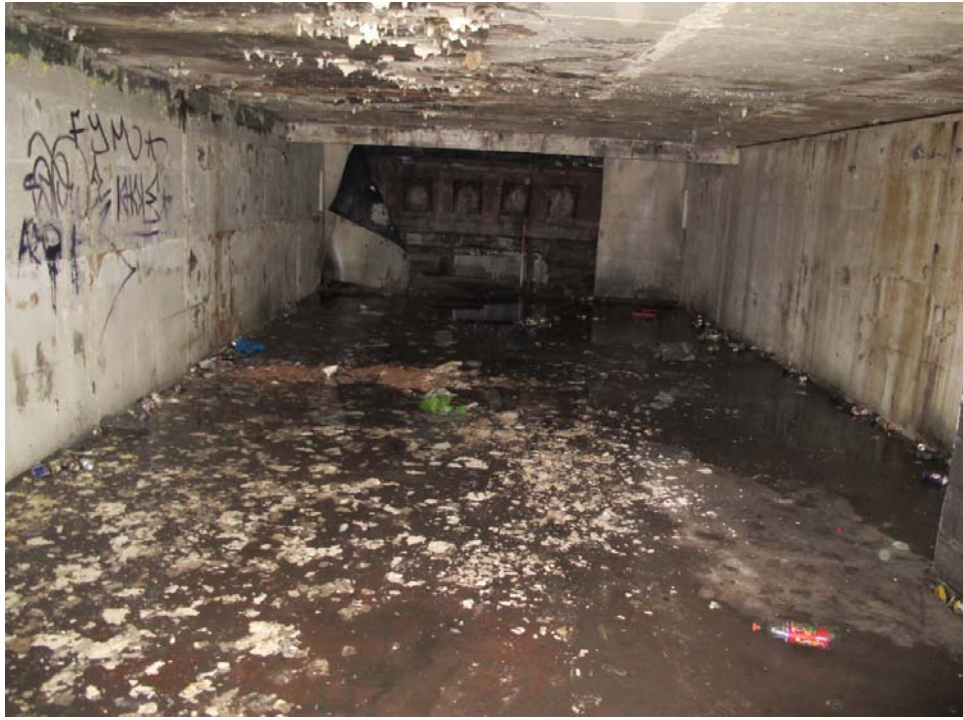
Figure 41: General shot of the short range shooting gallery in room F7, showing the metal sheeting of the butts area at the southern end of the room.

This room was located in the eastern portion of the building. The room was north-south aligned and measured 13.37m x 5.79m. Access to the room was from the north by a doorway in the north wall. The walls, ceiling and floor had been constructed from reinforced concrete slabs. The presence of five angled plates at the southern end of room suggested that the purpose of the room at the time of the survey was a short range shooting gallery. These angled plates would have been located in the butts, the area behind the targets (**Fig 42**). The targets themselves had not survived. Two blocked doorways were identified along the western wall (**Fig 43**) that may originally have led down into a room or walkway that ran around the operations room G4 at first floor level.

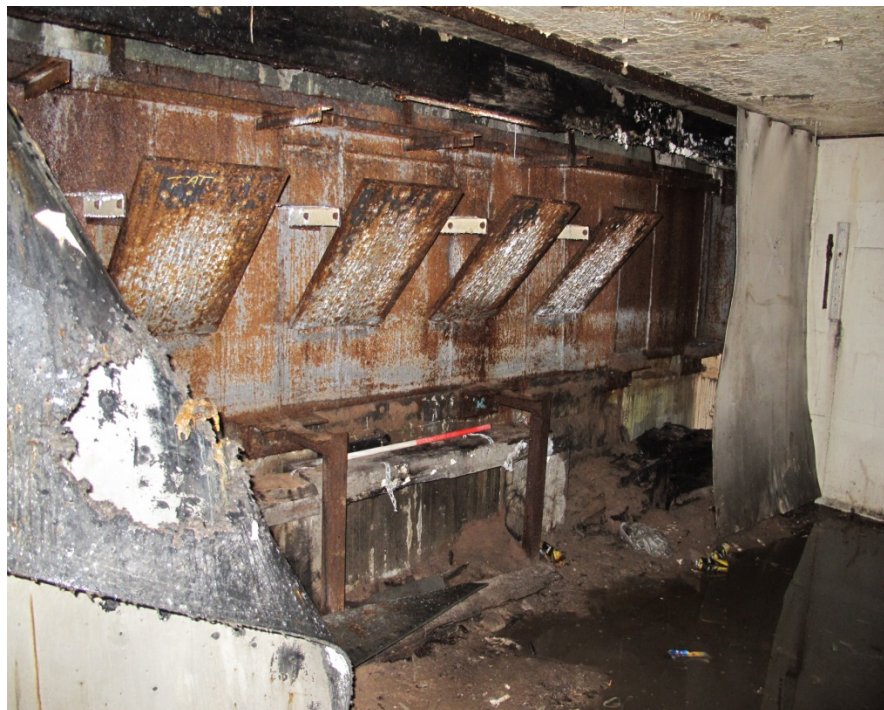
Figure 42: Detail of the butts area behind the damaged target area at the southern end of room F7. Looking southwest.

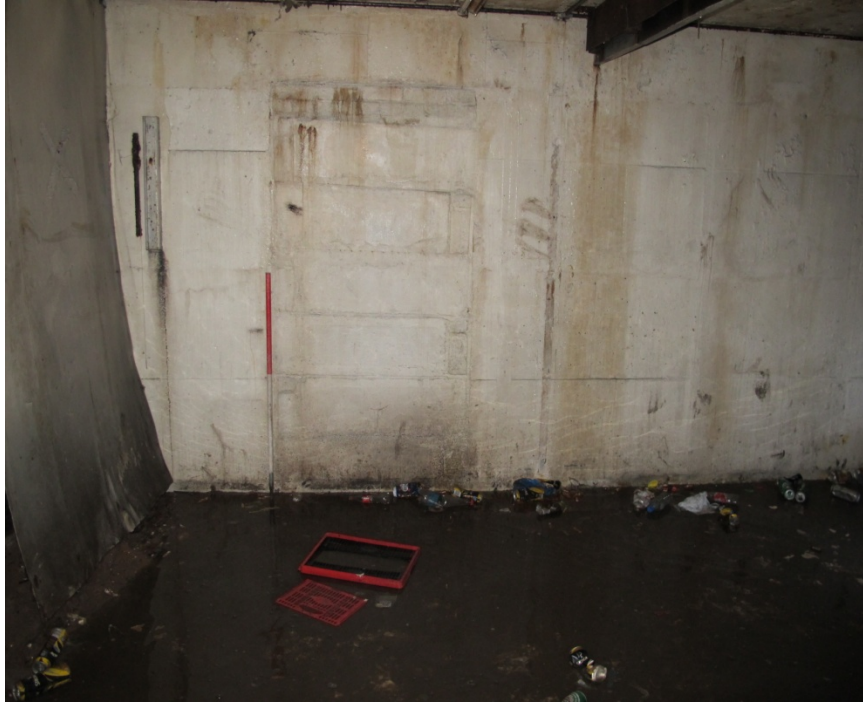
Figure 43: Detail of one of two blocked doorways located along the west wall of room F7. The doorway would have originally provided access to a walkway or room that ran around the top of the main operations room G4. Looking west.
